Yankton College Conservatory
Yankton College Campus
Yankton
Yankton County
South Dakota

HABS No. SD-14

HISTORICAL AND DESCRIPTIVE DATA

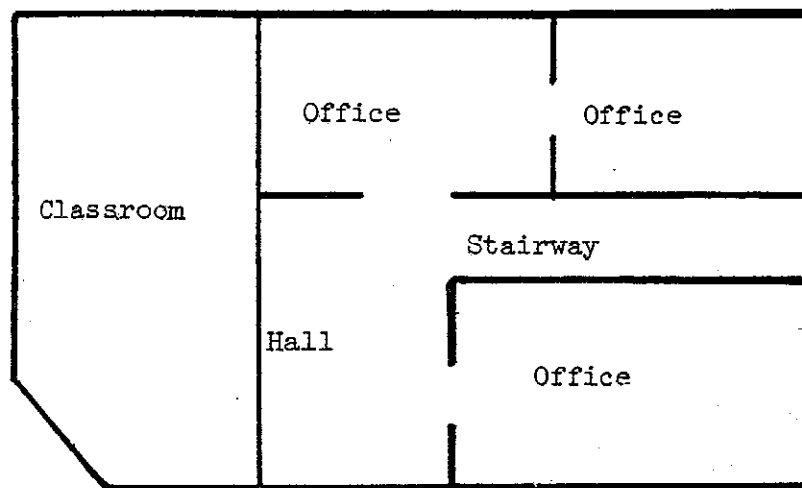
FIRST FLOOR

INTERIOR LAYOUT

SHAPE AND DIMENSIONS OF STRUCTURE (SKETCHED FLOOR PLANS ON SEPARATE PAGES ARE ACCEPTABLE) Rectangular plan with a chamfered corner at the west side (see attached for plans)		
EXTERIOR FEATURES OF NOTE The trim surrounding the windows are sandstone, but in other windows the trim is quartzite. Two sandstone stringcourses surround the building at the first and second floors. Sandstone quoins decorate the corners and the doorways. The third floor is a mansard roof; on its chamfered section is a plaque saying "Yankton College 1881". (con't to p. 2)		
INTERIOR FEATURES OF NOTE (DESCRIBE FLOOR PLANS, IF NOT SKETCHED) Not recorded when this report was written.		
MAJOR ALTERATIONS AND ADDITIONS WITH DATES The structure is basically unaltered.		
PRESENT CONDITION AND USE Good condition.		
OTHER INFORMATION AS APPROPRIATE The structure is listed in the National Register of Historic Places.		
SOURCES OF INFORMATION (INCLUDING LISTING ON NATIONAL REGISTER, STATE REGISTERS, ETC.) National Register of Historic Places Inventory-Nomination Form, 1975

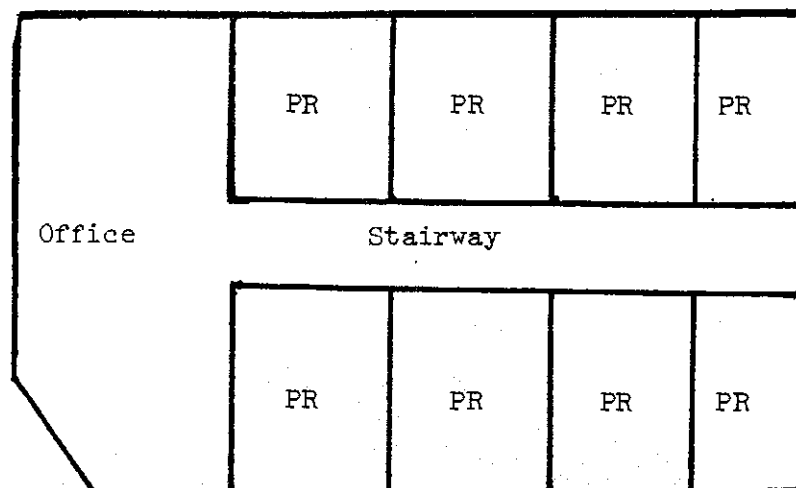
SECOND AND THIRD
FLOORS

PR= Practice
Room
